Manhole Inspection Summary

Manhole # S07WW1011MH

Insp Date: **9/12/06 3:44 PM**

Location Address: **3000 MANHATTAN AVE**

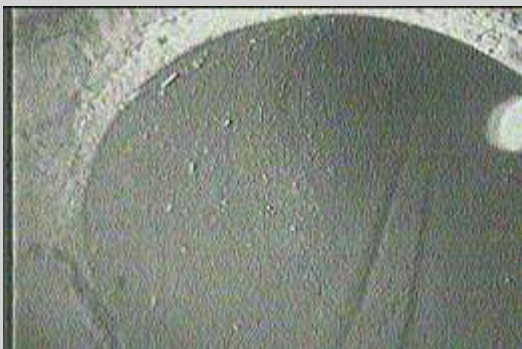
8 in. Circular Gravity Sewer Pipe In @ 3 O'Clock

Invert Depth: **10.15** (ft.) Flow Characteristics: **Slow**

Infiltration: **None** Pipe Seal Cond: **Unknown**

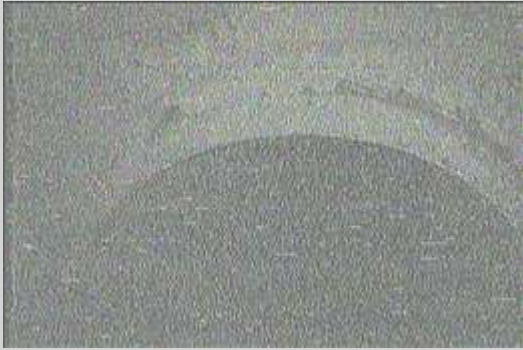
10 in. Circular Gravity Sewer

Infiltration: **None** Pipe Seal Cond: **Unknown**
